## **What a double glazed unit actually is**

## Final thoughts for homeowners planning Misted Double Glazing Repairs

CST Double Glazing Repairs

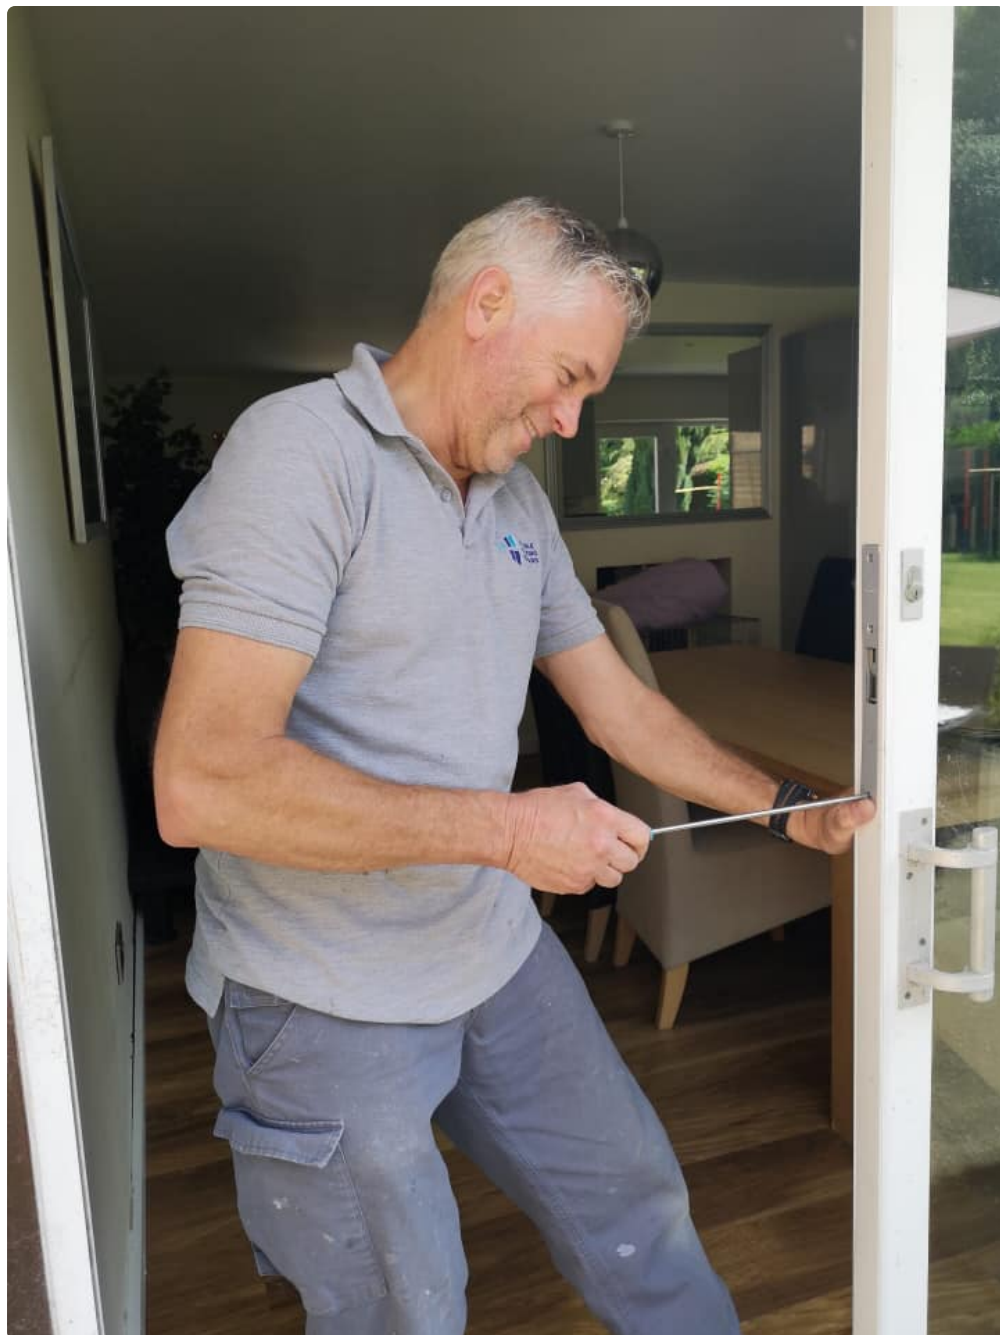
Most homeowners think of double glazing as "two panes with a gap." That's right, but the assembly matters. A standard insulating glass unit, or IGU, is made of two sheets of glass separated by a spacer bar. The spacer keeps a consistent cavity, usually 12 to 20 millimetres. The perimeter is sealed with adhesive sealants. The cavity is dehydrated with a desiccant inside the spacer, and often filled with an inert gas like argon to reduce heat transfer. The entire unit sits inside a frame, uPVC, timber, or aluminium, secured with glazing beads and occasionally a packer system.

The unit itself is a sealed product, not generally designed to be opened, cleaned internally, and reassembled. That means when it mists, you are rarely servicing the glass face. The real work focuses on replacing the failed IGU, or on more involved repairs that restore the moisture barrier and thermal performance.

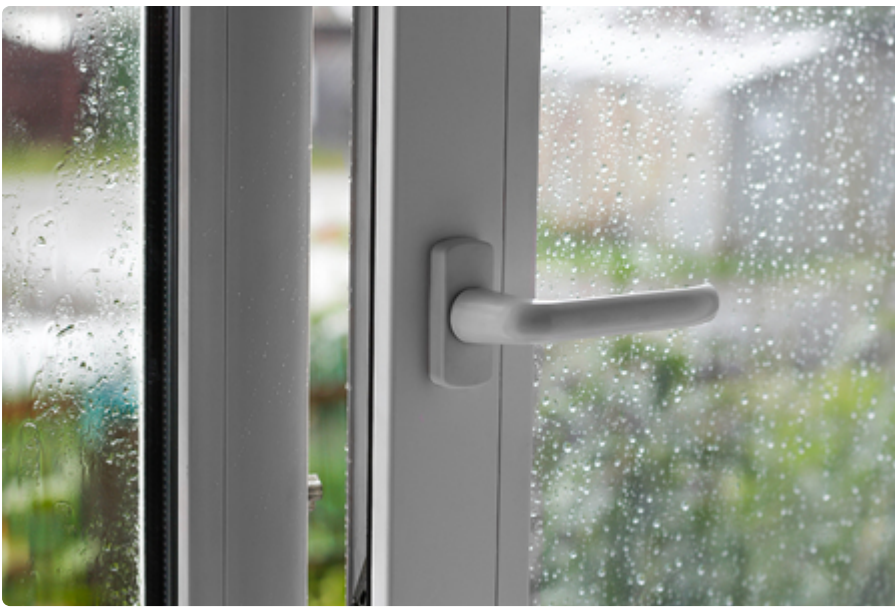
Inside the spacer is a desiccant, often a molecular sieve. It absorbs moisture that enters during manufacturing and any trace ingress over time. The capacity is finite. Once saturated, any new moisture has nowhere to go. Then the dew point inside the cavity rises and mist becomes visible at normal living temperatures. This explains why a unit can look fine for years, then cycle quickly from occasional fog to permanent mist.

A quick check in the field: if you see mist that forms first around the corners, where the spacer network meets, that often indicates the desiccant along that path is saturated. Even with a warm day, the corners stay milky. If the moisture is patchy and moves around, the cavity is taking on new air and the desiccant is in its final stretch. Either way, you are beyond a cosmetic issue.

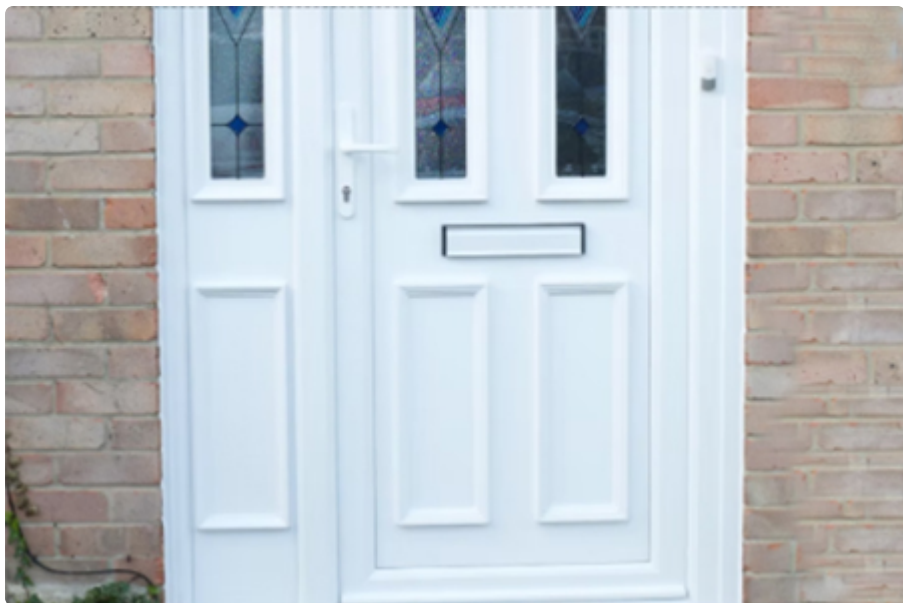
Some homeowners feel pressure to replace entire windows after misting, especially if a salesperson tells them frames are “past it.” I have pulled out uPVC frames from the late 1990s that were still structurally sound. The beading grew brittle, sure, but a careful hand kept it intact. Timber frames can go fifty years if kept painted and the sills are sound. Aluminium, unless corroded or suffering thermal break damage, rarely needs replacement simply because an IGU failed.

Look for these cues: warped sashes that don't latch correctly, water ingress around the frame to wall junction, rotten sills that flex under light pressure, broken thermal breaks, or persistent draughts despite new seals. Those justify a frame replacement. If you see none of that, a new IGU will probably do the job.
